**From:** Heidi Blischke <HBlischke@gsiws.com>  
**Sent:** Wednesday, August 05, 2015 12:27 PM  
**To:** Palumbo, Janice; Fuentes, Rene  
**Cc:** Georgia Baxter; Steven Kuhlmeier; Randy Pratt  
**Subject:** Arlington, Washington JH Baxter Recirculation Trench Field Effort Summary  
**Attachments:** removed.txt

The field work to rehabilitate the recirculation trench and install the iSOCs in Arlington went well and is summarized below.

## Work Summary

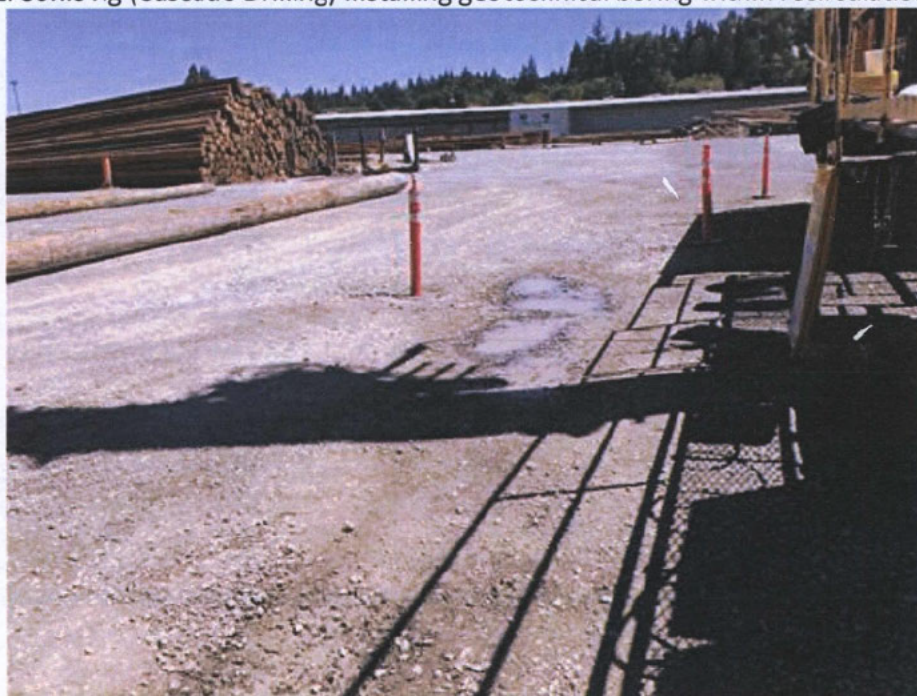
- The trench is situated within a primary access roadway for Stella Jones' plant operations. As such frequent heavy equipment traffic and dust suppression activities occur atop the trench. The surface above trench is currently used as a surface drainage pathway (Figure 2) where minor water ponding was present at time of visit.

Figure 2. Viewing east of grading atop east/west leg of infiltration trench.

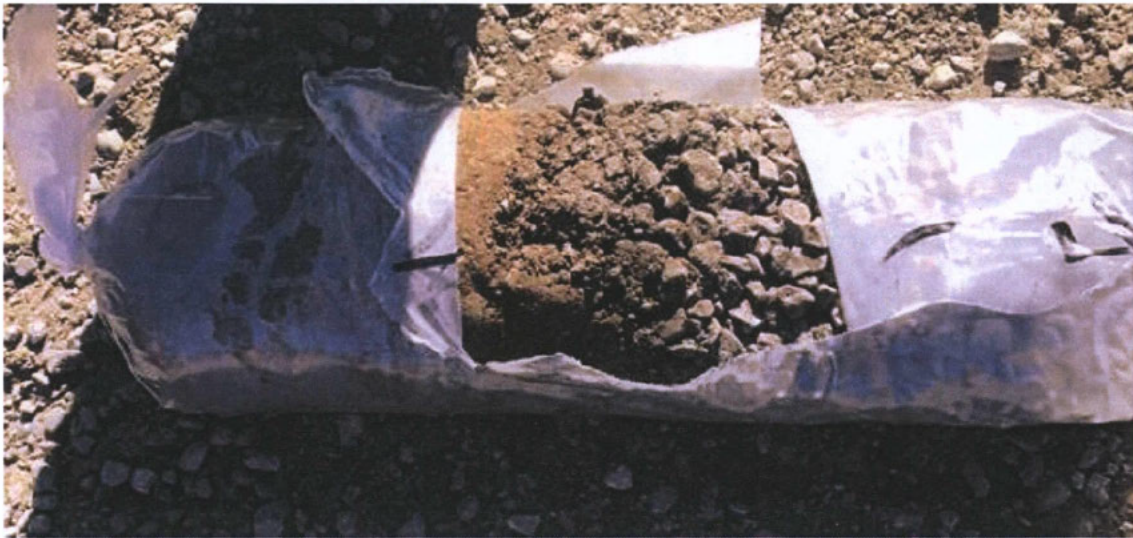
- Extracted soil cutting from the trench displayed sands and fines present within trench fill material. Fines appeared to be concentrated at the bottom of the infiltration trench's fill material (1-2" gravel) at the interface of native material and the trench (Figures 3 and 4). We suspect that it was this silt at the interface that prevented/reduced infiltration.

- No apparent biofouling was seen within the trench or native material, as initially thought. Therefore, as mentioned above, it appears that the silt at the interface between the native material and the trench was preventing or reducing the ability of recirculated water to infiltrate.
- Soil cutting from each boring were drummed (55-gal) and stored adjacent the Baxter equipment shed. Soils did not show visual contamination nor was an odor detected in any of the borings.

Figure 3. Soil cutting at approximately 6-7 ft bgs, apparent interface of bottom of trench and native soil.

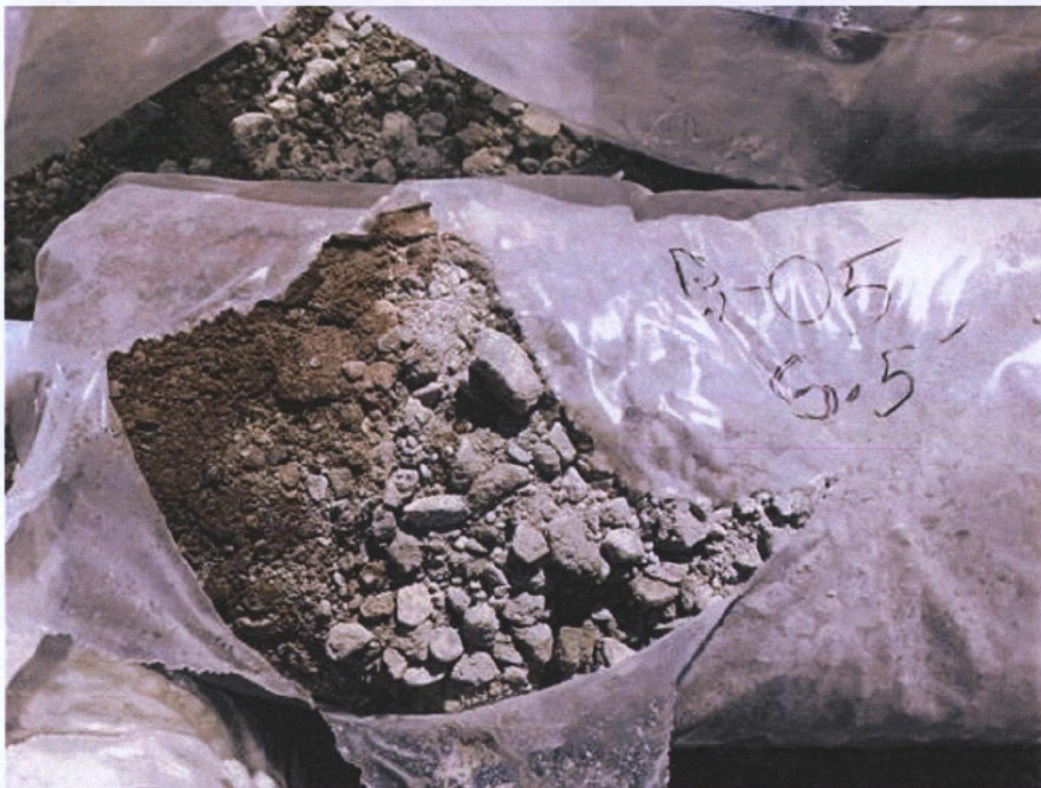
Figure 4. Soil cutting at approximately 6.5 ft bgs, apparent interface of bottom of trench and native soil.

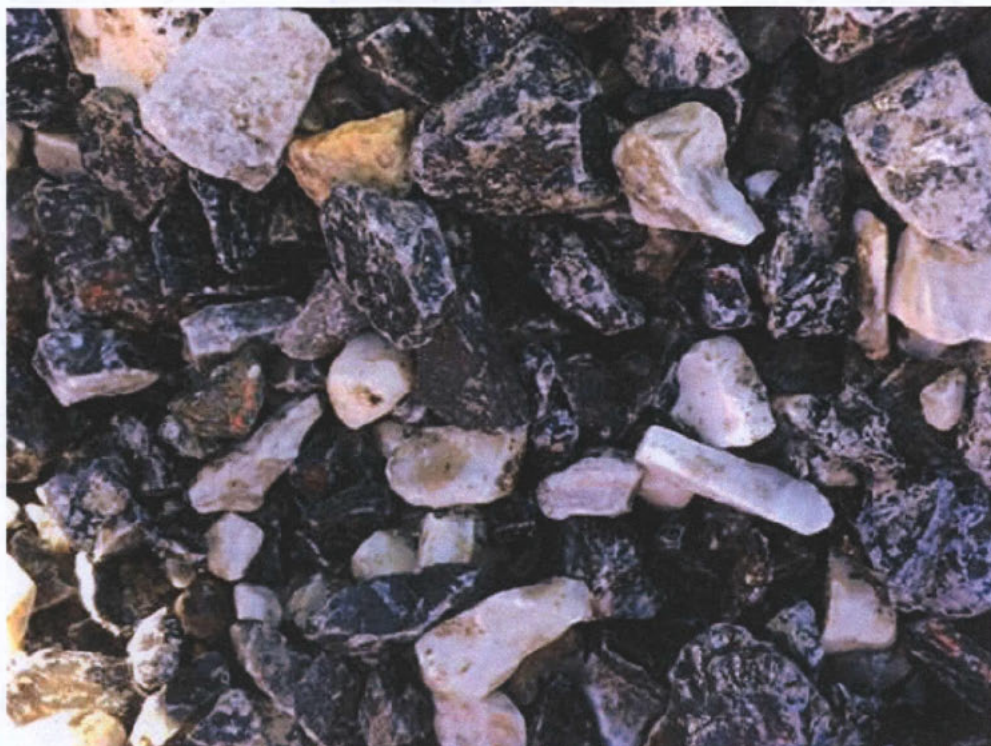
- The gravel fill found within the trench appears to contain only a percentage of limestone rock, with the remaining fraction consisting of a basalt gravel (Figure 5).

Figure 5. Washed infiltration trench fill rock, 1/2" to 2" sizing.

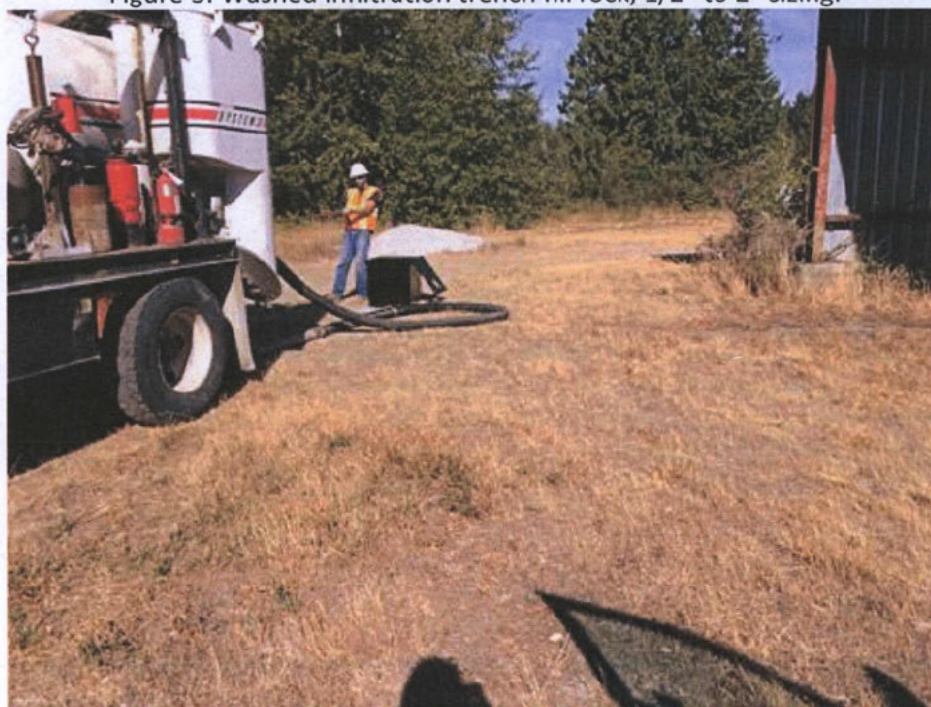
On August 1<sup>st</sup>, 2015 GSI installed three iSOC infusion units within monitoring wells MW-39, MW-40, and MW-41. The vaults (Figure 6) for these wells were replaced using vacuum truck provided and operated by Cascade Drilling, iSOC units and related materials were provided by GSI.

Figure 6. Well vault installation for iSOC deployment (Cascade Drilling).

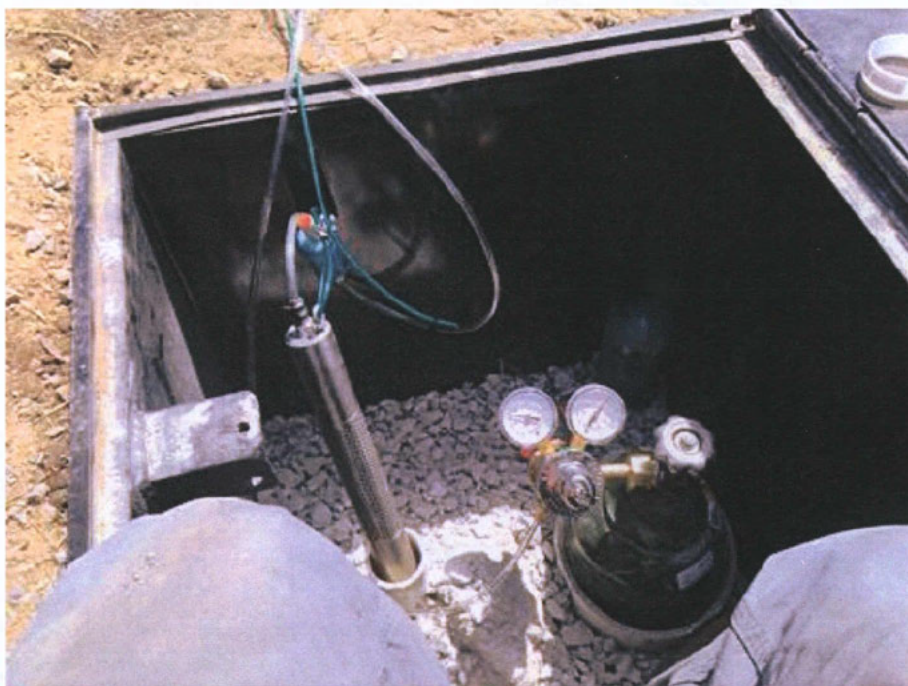
- iSOC units were deployed to near the bottom of each respective well (approximately 75-78 ft bgs) and were connected to individual oxygen tanks stored within each well vault (Figure 7). The oxygen tanks were procured from a local Airgas distributor.
- The compressed oxygen tanks contain approximately 60 cf of oxygen apiece and are expect to sustain operation of each unit for 45 days.
- The well vaults are flushed mounted, traffic rated, and secured with a lock (Figure 8).

Figure 7. iSOC well vault prior to deployment.

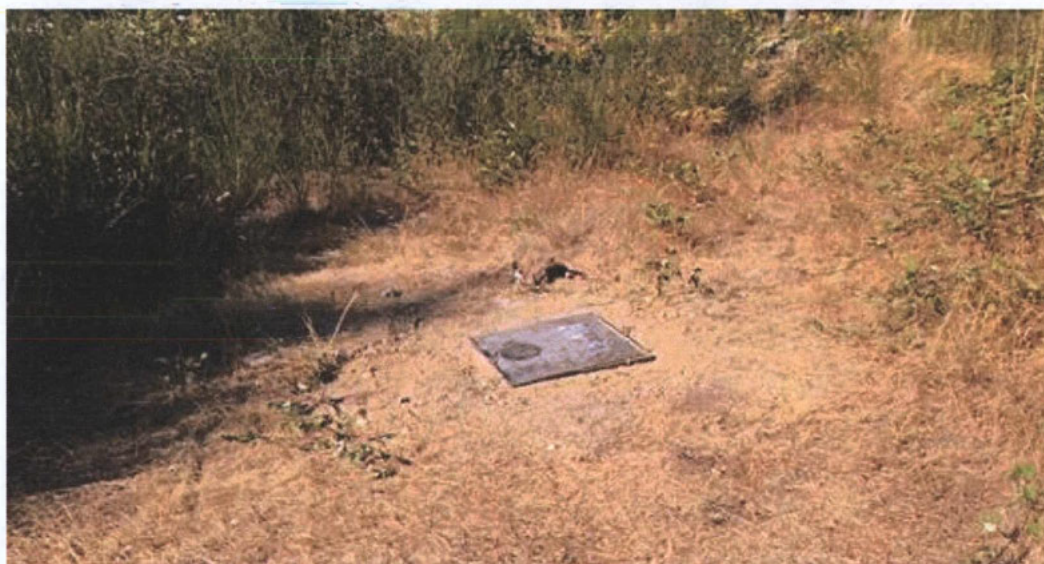
Figure 8. iSOC well vault finished (MW-41).
